# Insec(tc)ure\*:

A UT Urban IPM Lab Newsletter for the Pest Management Industry

### Interesting Drywood Termite Structural Infestation

*Karen Vail, UT Entomology & Plant Pathology, and John Cook, Massey Services*

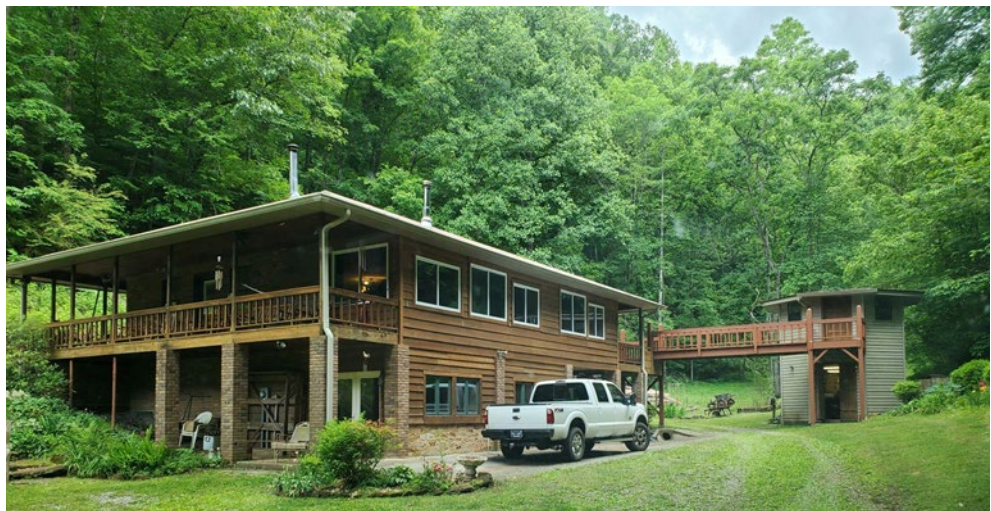
*Figure 1. Englewood home with drywood termite infestation on three levels. Credit: John Cook, Massey Services*

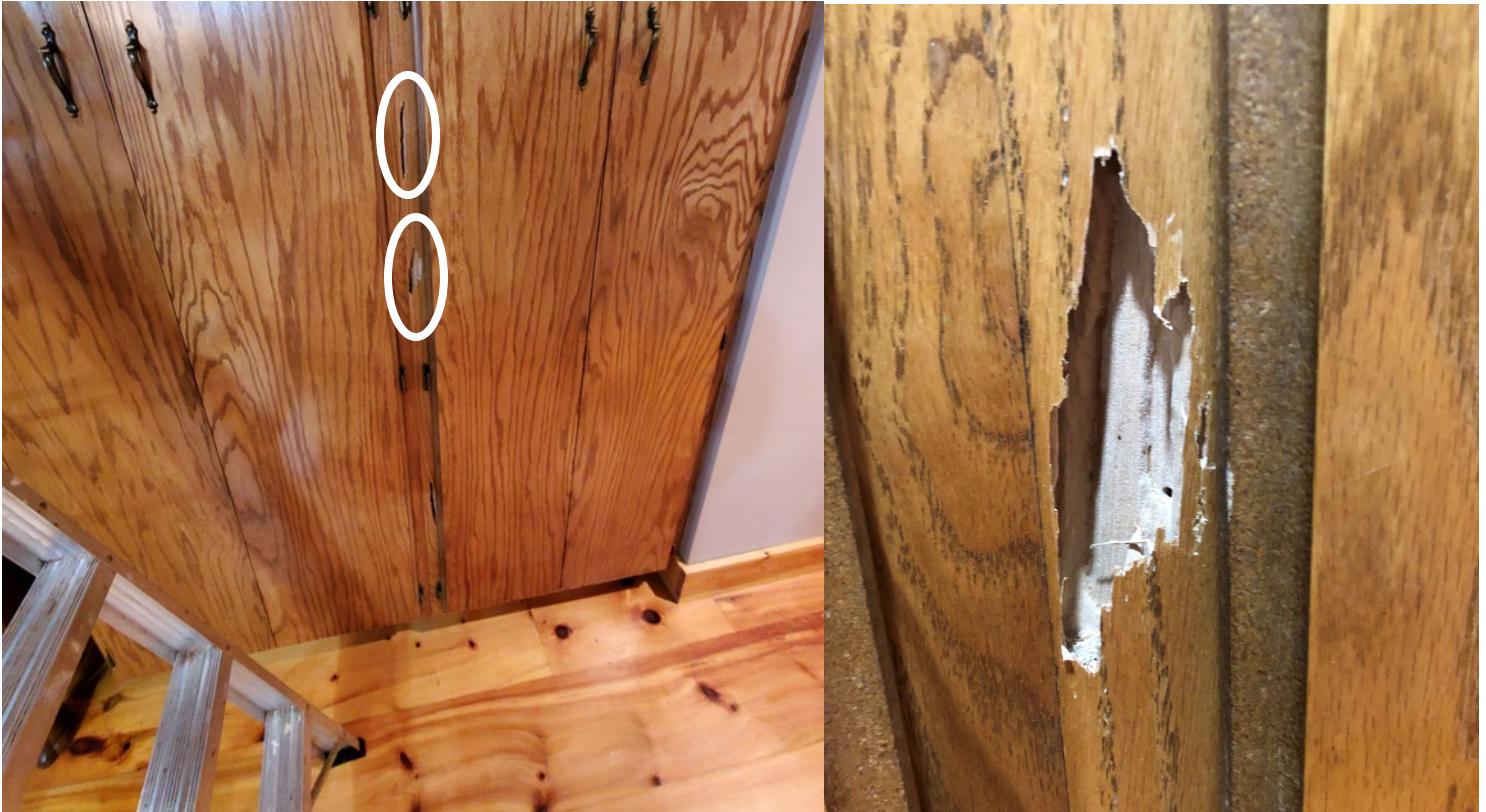
Drywood termite damage was found on three levels. Earlier, the homeowners had noticed “sawdust” on the wooden stairs, and a couple of years ago, they had replaced an exterior door because it had drywoods in the molding around the door. But on our visit, we found damage to the wooden cabinets on the second floor in the kitchen (Figure 2), the stairs leading to the first floor (Figure 3) and wooden paneling near a window in the basement/first floor (Figure 4 - 6), and in the ceiling joists and elsewhere in the attic (Figures 7 -10). Let’s take a closer look.

Figure 2. On the left, two drywood termite chambers circled in white were exposed when the thin wooden top layer of these kitchen cabinets was removed. Credit: John Cook. On the right is a close-up of these chambers. Credit: Karen Vail

So, we had wood damage on three levels, an exterior wall was infested, and mating flights were occurring in the attic. We didn't think localized treatment was an option as the infestation was too widespread, and we had evidence of it in the structural support wood. A tarped fumigation would be the best solution. But this is East Tennessee. Where could we find a PMP licensed in structural fumigation with tarps? Because we had activity in the structure's exterior wall, we thought it was essential to have tarps to maintain the fumigant in the exterior walls. Taping and sealing windows and doors may not have maintained the needed fumigant levels and times in that exterior wall.

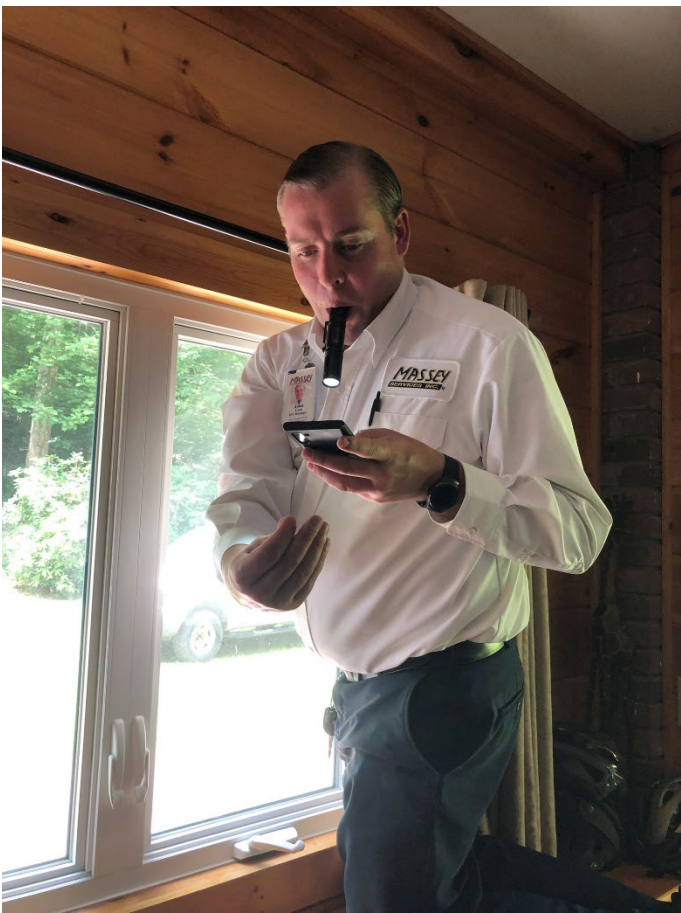
Figure 5. John Cook photographing the kickout hole plug. Credit: Karen Vail

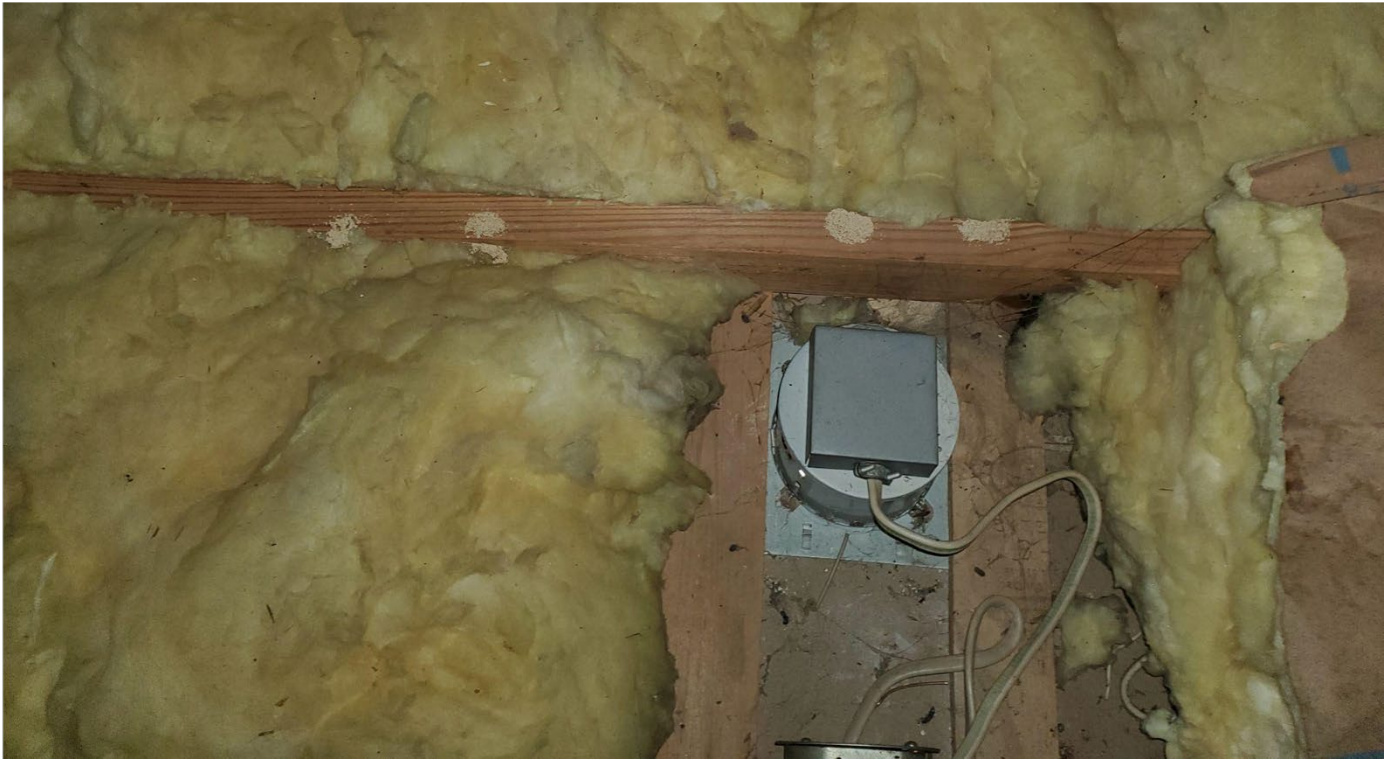
*Figure 7. Piles of drywood termite 6-sided fecal pellets piled high on the attic floor joists. Normally, the fecal pellets fall to the ground, but the insulation on the sides of the board prevented the termites from creating a side gallery opening. Credit: John Cook*

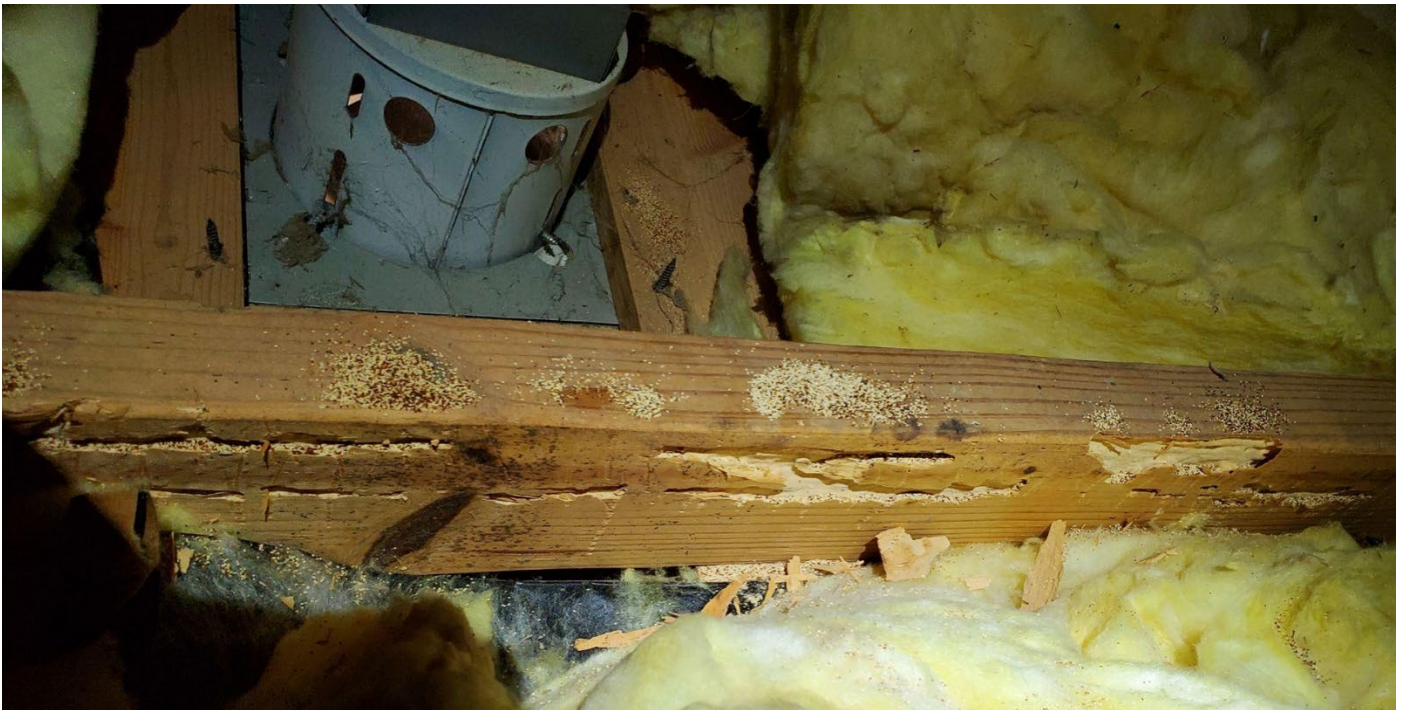
*Figure 8. A pocketknife easily removed the thin wood hiding the termite chamber. Drywood termites leave a thin layer of wood to protect the colony in the chamber. Often the wood is puckered in these locations and serves as a clue to the termite galleries' locations. Credit: John Cook*

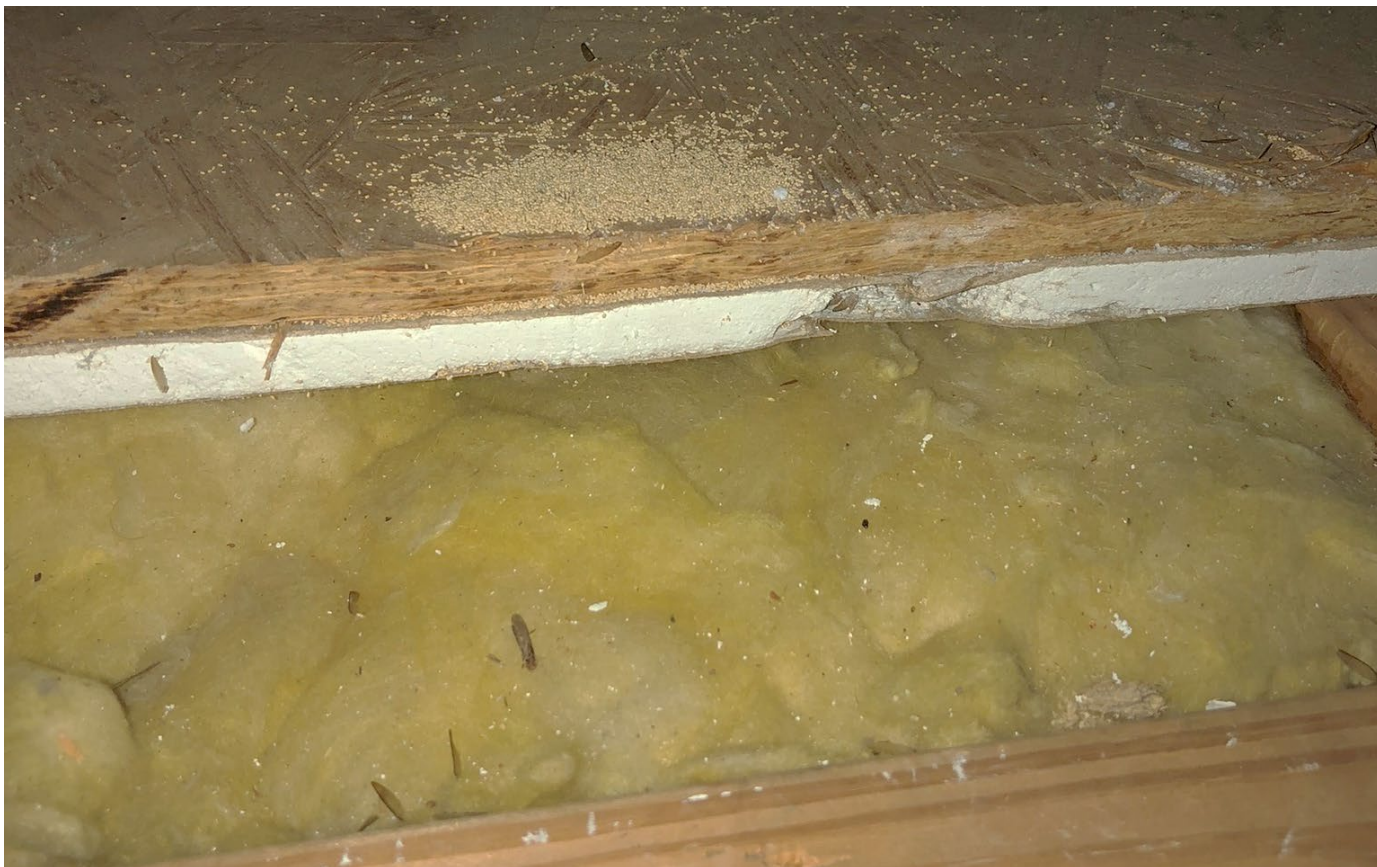
*Figure 9. Two signs of drywood termites are found in this photo (1) pile of 6-sided fecal pellets and (2) swarmer wings. The pile of pellets in the photo is on top of the attic access panel so there was a colony at the very edge of the attic just feet away from those cabinets. No drywood colonies were found above the rafters. Credit: Karen Vail*

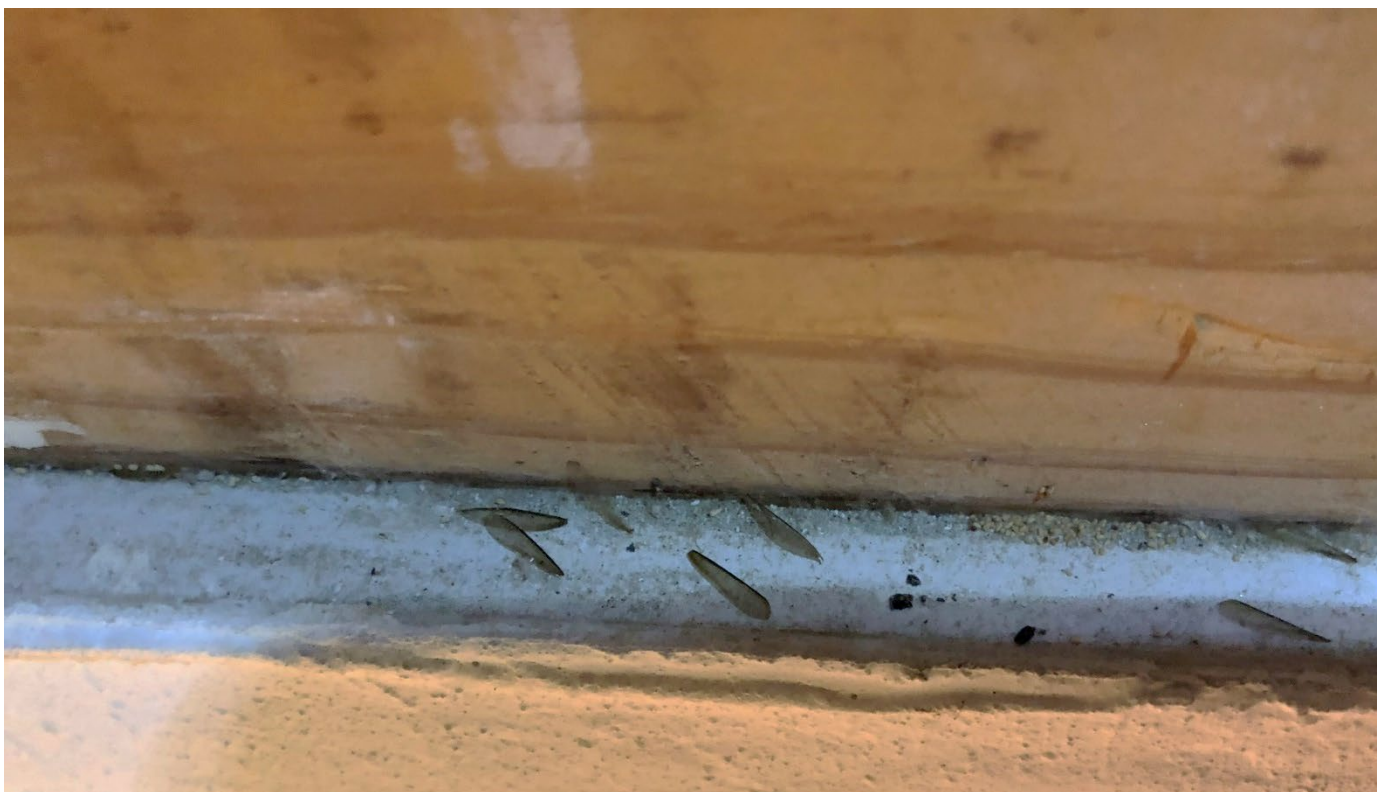
*Figure 10. Alates were flying when we opened the attic hatch. Credit: Karen Vail*

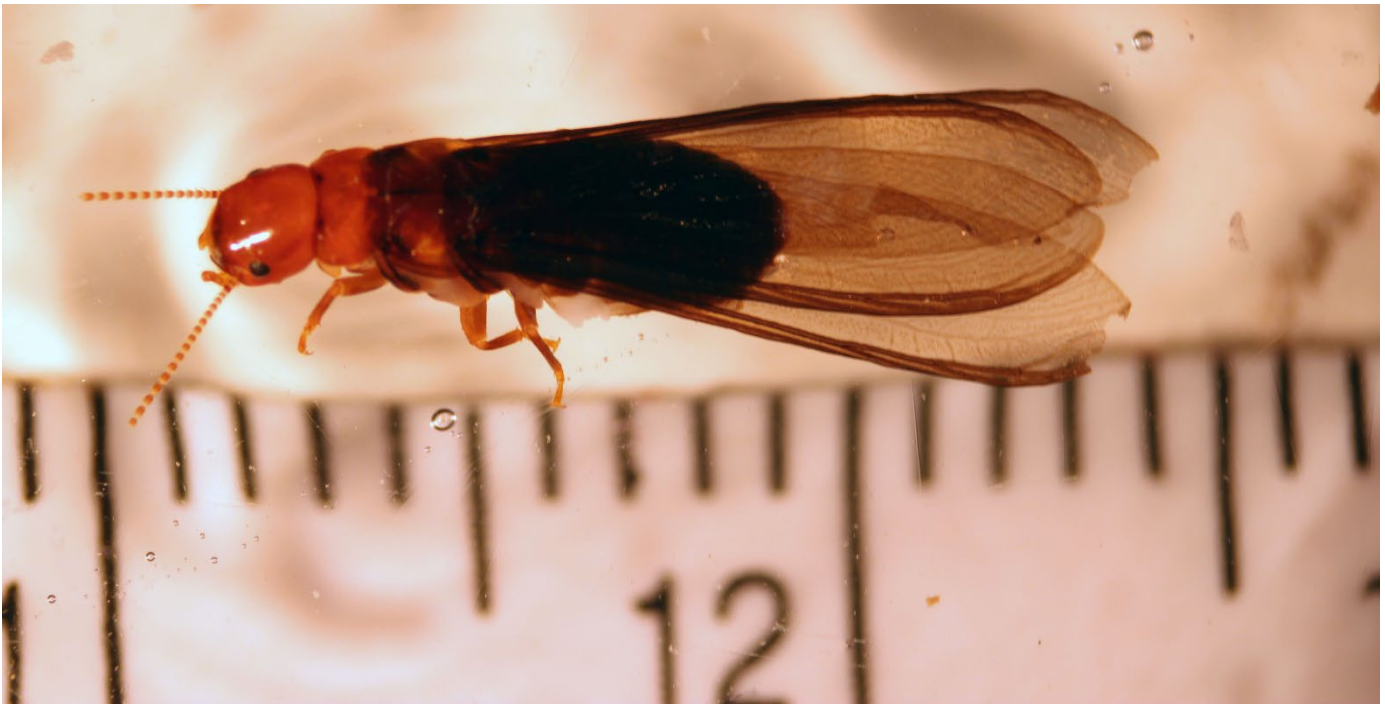
Figure 11. The drywood termites from the Englewood infestation were identified as the western drywood termite, *Incisitermes minor*. Ruler is in millimeters Credit: Karen Vail

Specimens brought back to the University of Tennessee Urban IPM Lab were identified as the western drywood termite *Incisitermes minor* morphologically using a microscope (Figures 11 – 13) and molecularly using the 16s ribosomal gene. The western drywood's range is from southern California and Baja Mexico up the coast to northern California, and it is found sporadically along the coasts of Washington and Oregon. Eastward, it naturally occurs through central Arizona. But it's been introduced beyond this range, including in the southern U.S. coastal states. The western drywood termite has been found outdoors in a New Orleans tree, creating concern for the coastal southeastern U.S. where boats can easily be a source of alates. Identifying western drywood termites as the culprit supports our theory that the original California inhabitants may have brought the termites in their furniture.

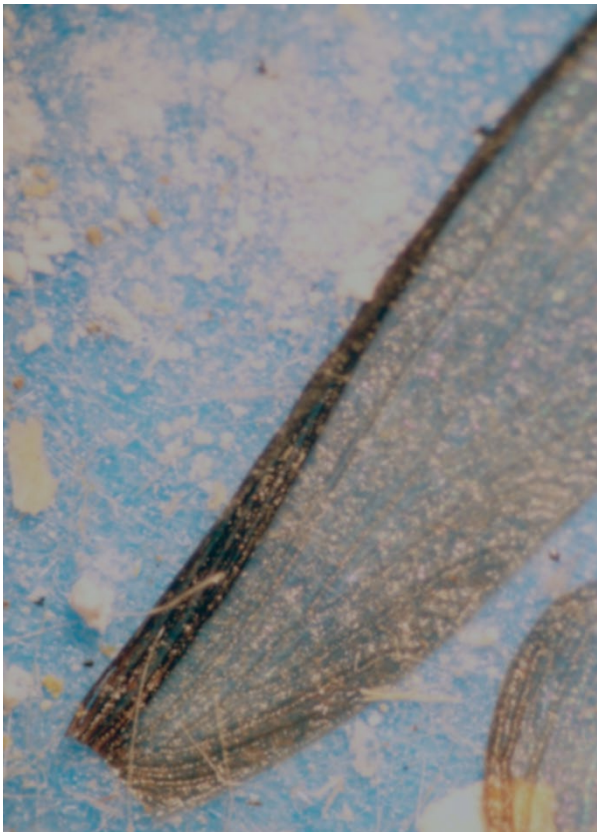
Figure 12. Drywood termites have 3 - 4 darkened wing veins along the front edge of the forewing. Subterranean termites have 2. The numerous diagonal cross veins connecting those edge veins are more easily seen in Figure 11. Credit: Karen Vail

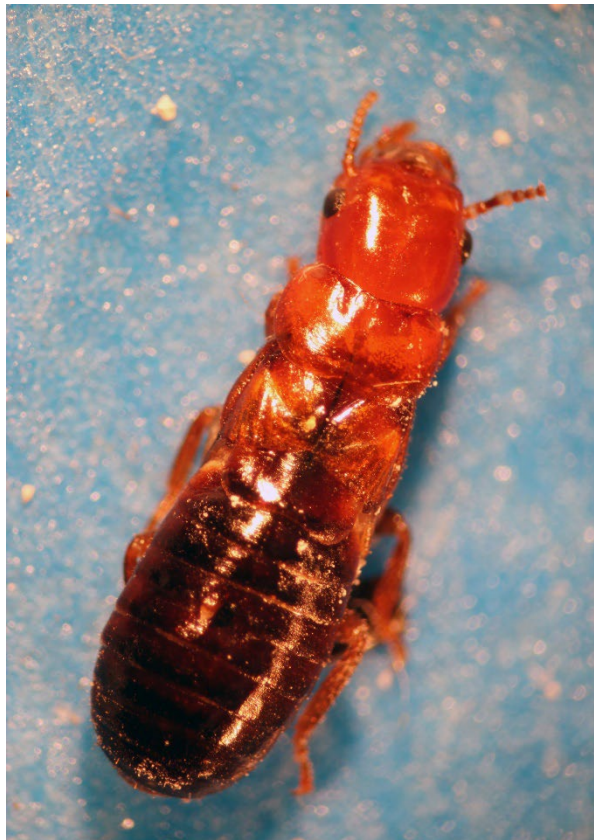
Figure 13. The coloration of the western drywood alate (and de-alate seen here) easily distinguishes it from other termites. Note the orangy-brown head and thorax, and darker abdomen. Credit: Karen Vail

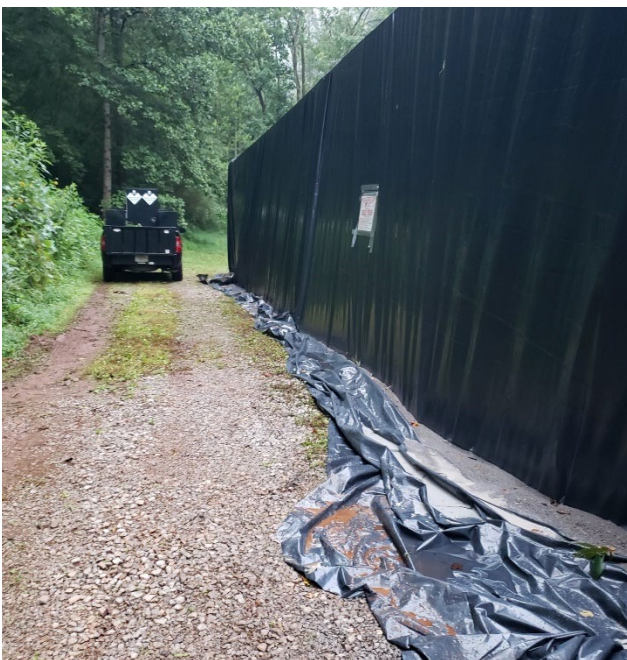
Figure 14. Plastic installed by the family covered the house before fumigation began. Credit: homeowner

Buddy searched the TDA databases, and John searched in Georgia for someone with drywood termite fumigation experience, tarps and a Tennessee license in structural fumigation (FUM). While drywood termites are found in Georgia and folks fumigate, none they could find were licensed for fumigation in Tennessee. Plus, DOT regulations about driving fumigants over state lines would require additional training and testing. It wasn't looking good. Enter the story of Tennessee Fumigations LLC out of Dandridge. Deidre Hubbard and Terry Hazelwood fumigate for bed bugs and many other pests but do not use tarps. Upon inspecting the Englewood property, they proposed to the owners that they tarp the structure themselves. The family purchased the tarps and clips, called in family members from around the country and covered the house in plastic tarps using directions from Tennessee Fumigations (Figure 14). On August 7, the Vikane (sulfuryl fluoride) fumigation began (Figure 15).

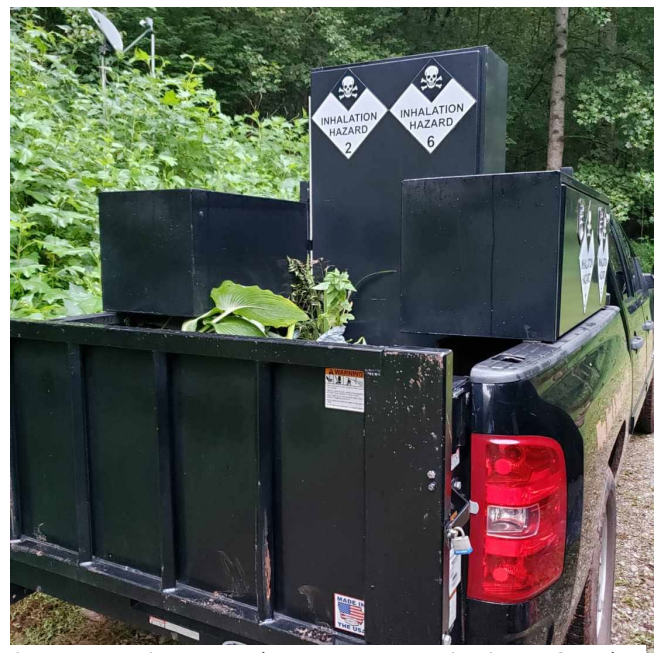
Figure 15. Fumigant stored on Tennessee Fumigations LLC truck. Credit: homeowner
